# Disassembling Kenwood Chef A701A Gearbox and Orbital Mixer assembly

Dissassembly of the top half of the Kenwood Chef A701A to investigate the low speed attachments not working - this could be due to belt or gearbox failure, but is usually due to a plastic gear mounted on a pinion failing. This guide covers replacement.

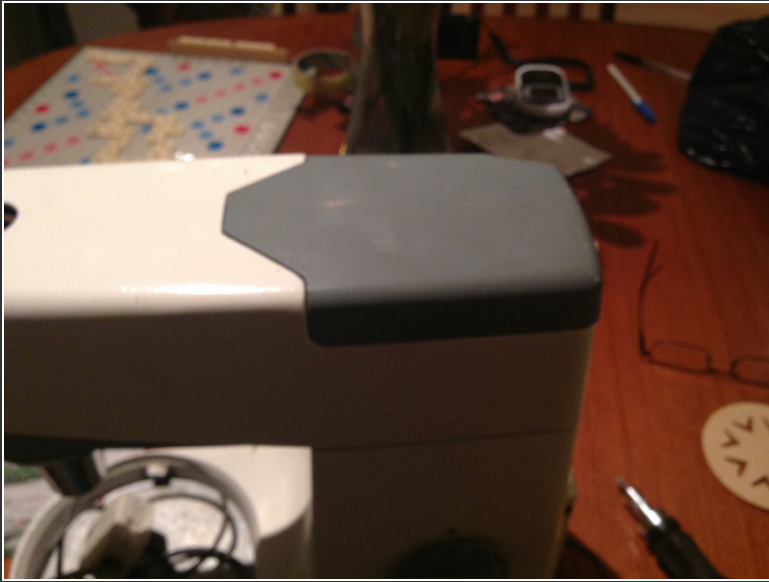
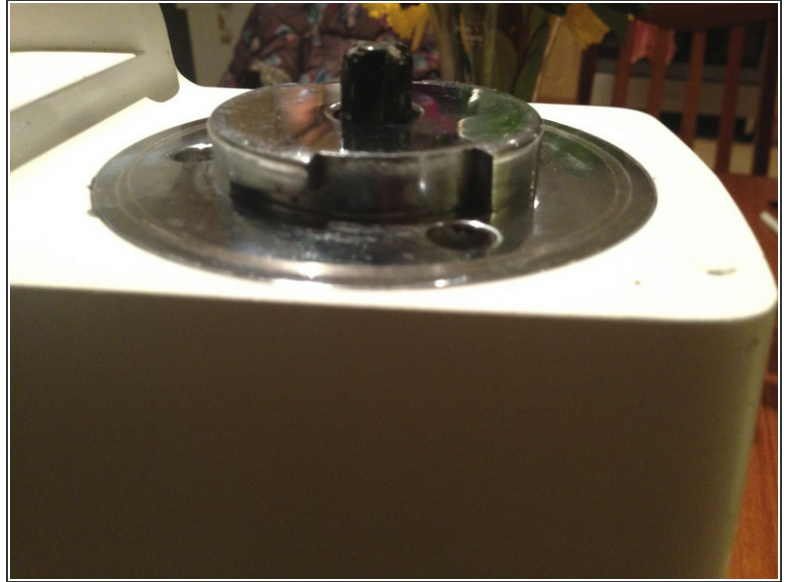
## Step 1 — Gearbox and Orbital Mixer assembly

- Before doing anything, ensure that the mixer is not plugged in! Then, remove the cover from the high speed attachment. If you don't have this cover, then the low speed attachments will not work anyway, as the cover engages the clutch when it is latched on.

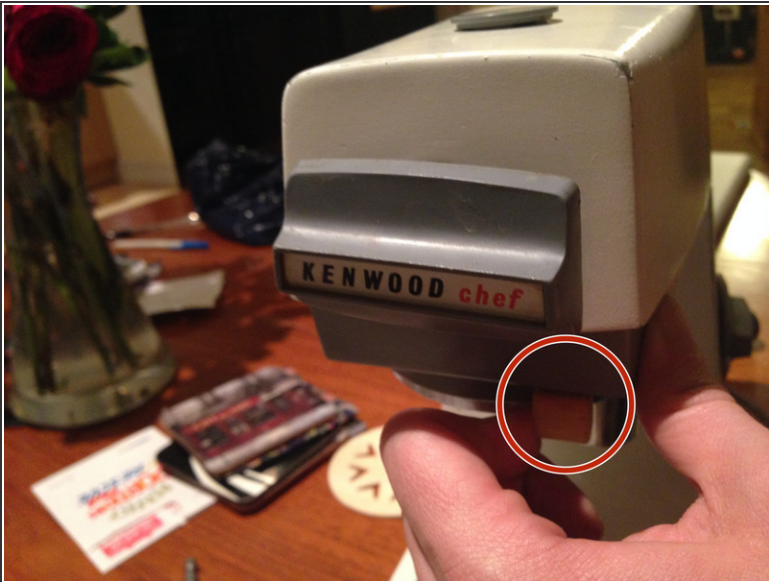
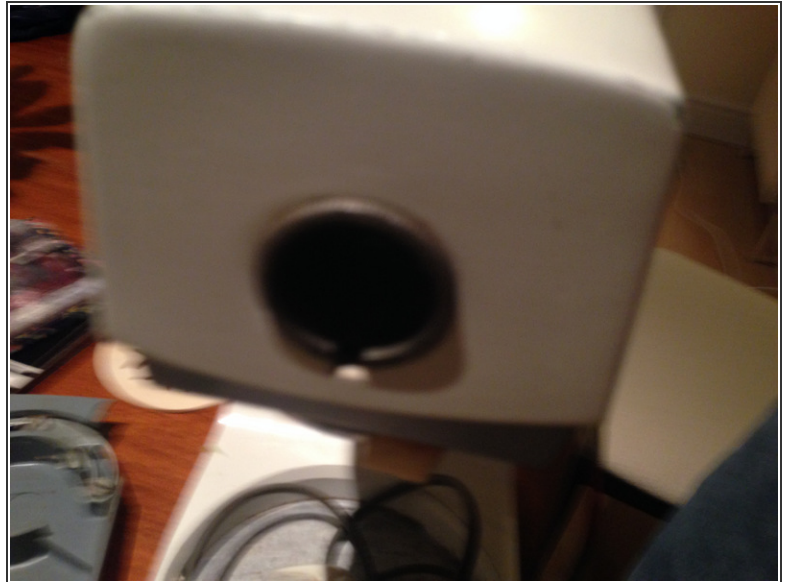
## Step 2

- Now, remove the kenwood chef logo covering the front grinder attachment by pulling the white handled lever towards the edge of the mixer and then pulling the Kenwood panel away from the mixer.

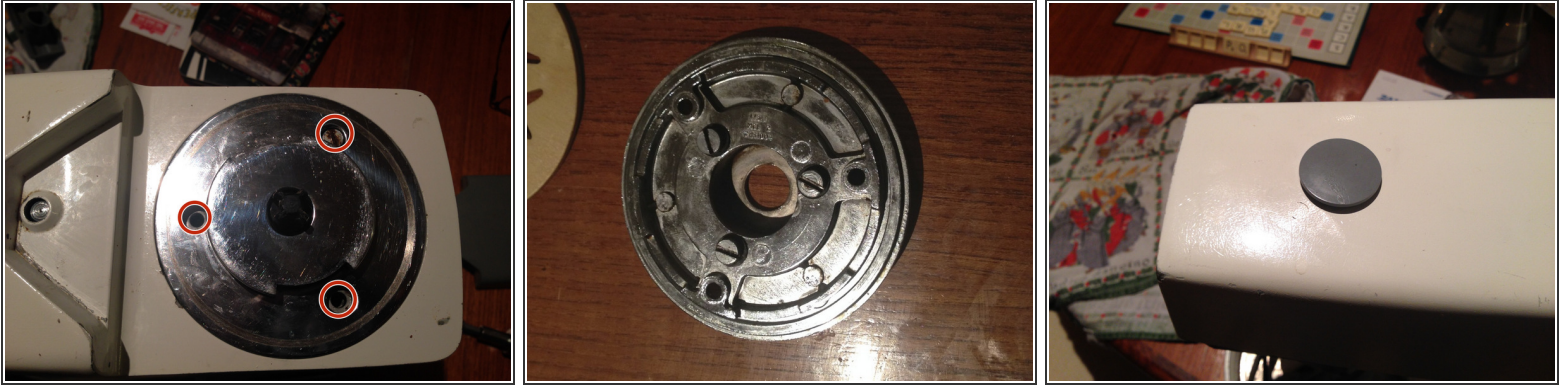
### Step 3

- Next, unscrew the three screws holding the high-speed attachment port in place. Once removed, the attachment port lifts up freely.
- Then, take the plastic cover off the other attachment port on the top of the mixer.

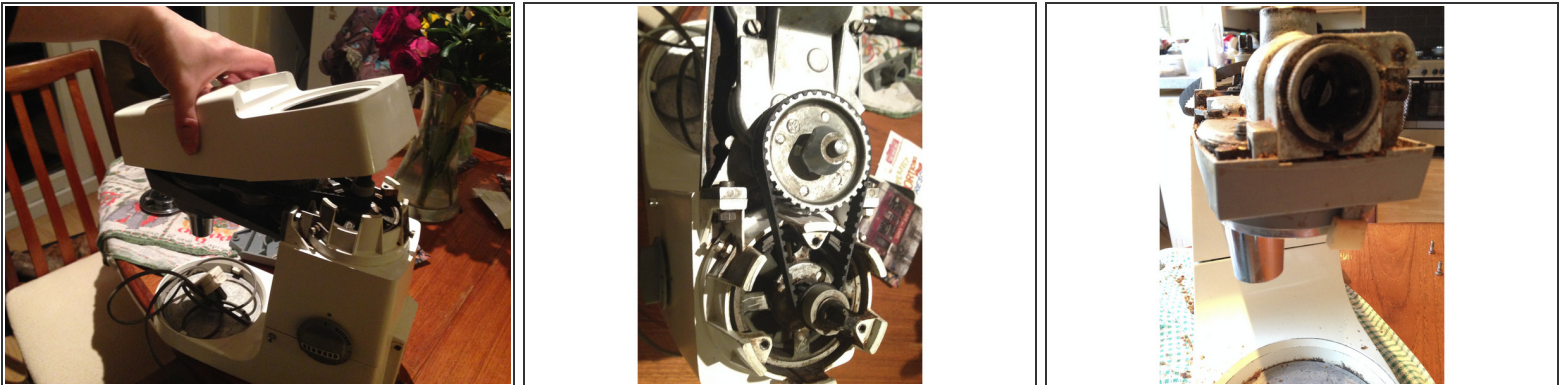
### Step 4 — Remove the gearbox cover

- Now, lift the gearbox cover up and towards the front of the mixer - it should slide straight off
- Marvel at the decades of ingredients stored safely inside your mixer!

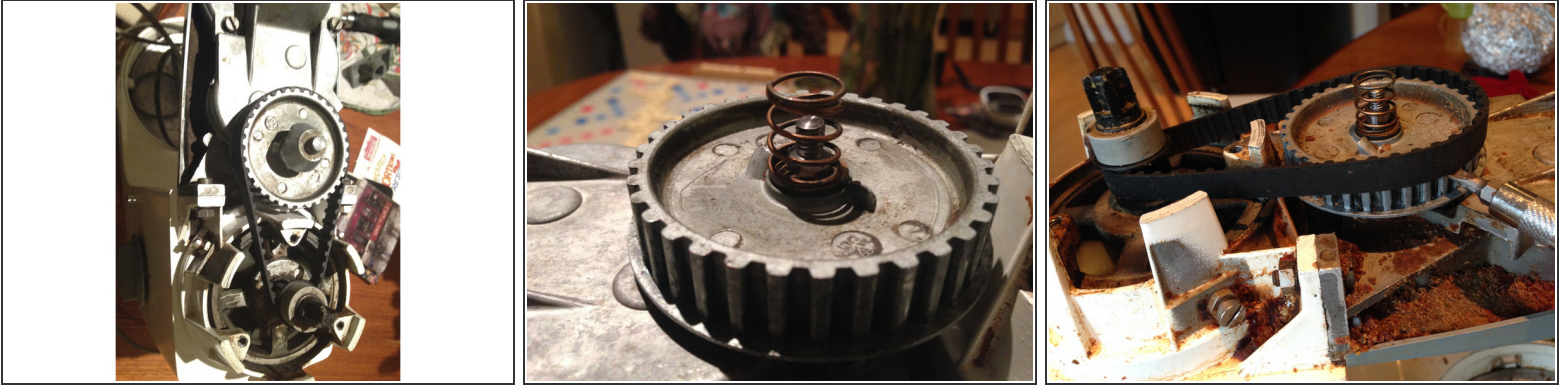
## Step 5 — Remove the drive belt and springed gear

- You can remove the belt that drives the gearbox at this point - if this has worn out then only the high speed attachment will have been working. It will lift off nicely with a screwdriver.
- The large gear then needs to be gripped, and the "dog" on top of it needs to be removed. You'll need to hold the gear in place and turn the dog, and watch the spring doesn't fly off!
- Apologies for the cake/belt continuity errors in this set - some are taken during reassembly

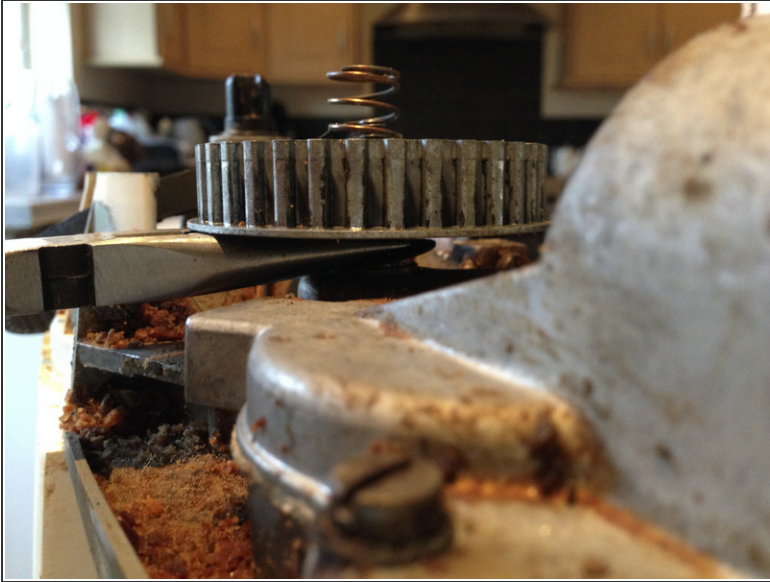
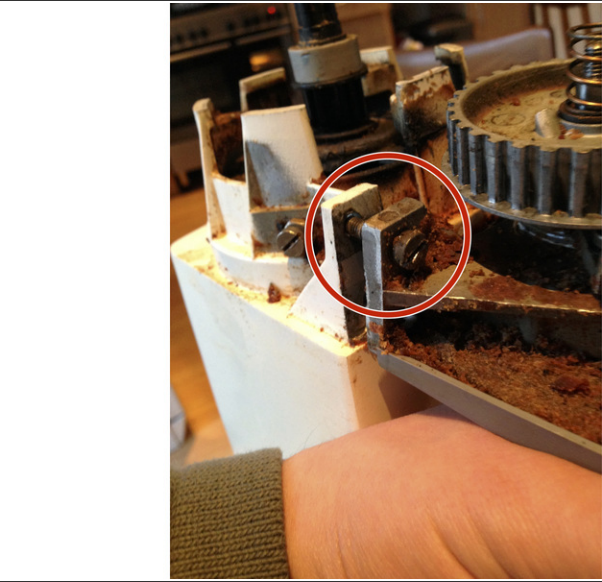
## Step 6 — Remove/Service the Gearbox - Part 1/3

- If you just need to remove the large gear, here's the time to do it. You can lift it off with a pair of pliers underneath. Note that this is attached to a plastic gear inside the gearbox and this is the usual failure point if your low speed attachment is not working but your mixer runs.
- Next, undo the screws holding the gearbox onto the mixer body. There is one on either side of the mixer (only one shown). If your motor is dead, you may not need to do this.

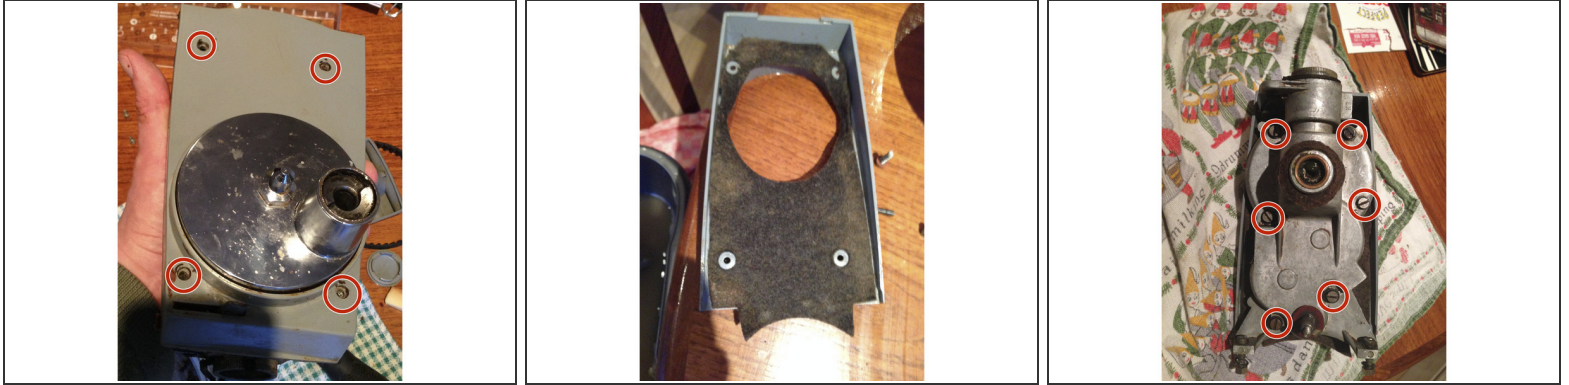
## Step 7 — Remove/Service The Gearbox Part 2/3

- Next, remove the plastic cover on the bottom of the gearbox. At this point, old crumbs will be getting everywhere. This is held on by four screws, which are removed in the first picture. At this point, you also need to pull the plastic cover off the lever at the front of the mixer.
- You now have access to the lower plastic cover - best to give this a wash along with the felt. (picture 2)
- Behold the beauty of the Kenwood gearbox (picture 3). Best not to wash this, but remove the 6 screws to gain access.

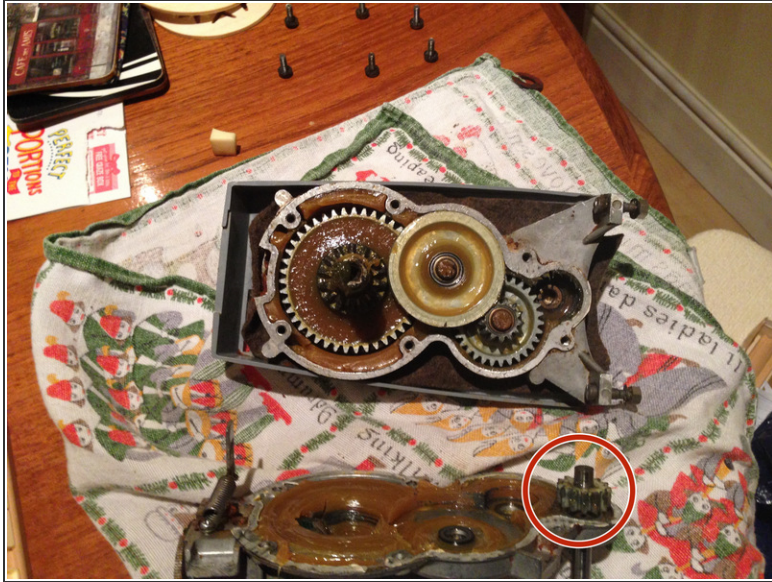
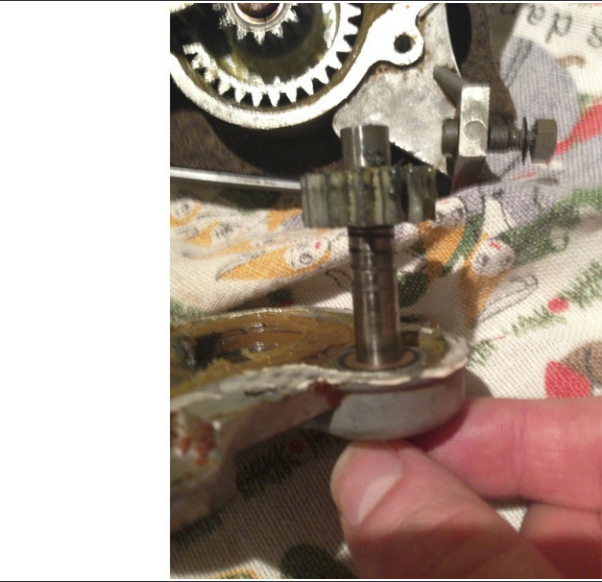
## Step 8 — Remove/Service The Gearbox Part 3/3

- One thing to do with that - open it up! The cover lifts off showing the still well lubricated gears. Normal failure point ringed - remove this and replace with a new one to fix!
- Reassembly is the reverse of dismantling the mixer.

To reassemble your device, follow these instructions in reverse order.
